OSSIX® PLUS Case Presentation #5

A 57 year old male with severe periodontal-endodontal lesion in tooth #5.

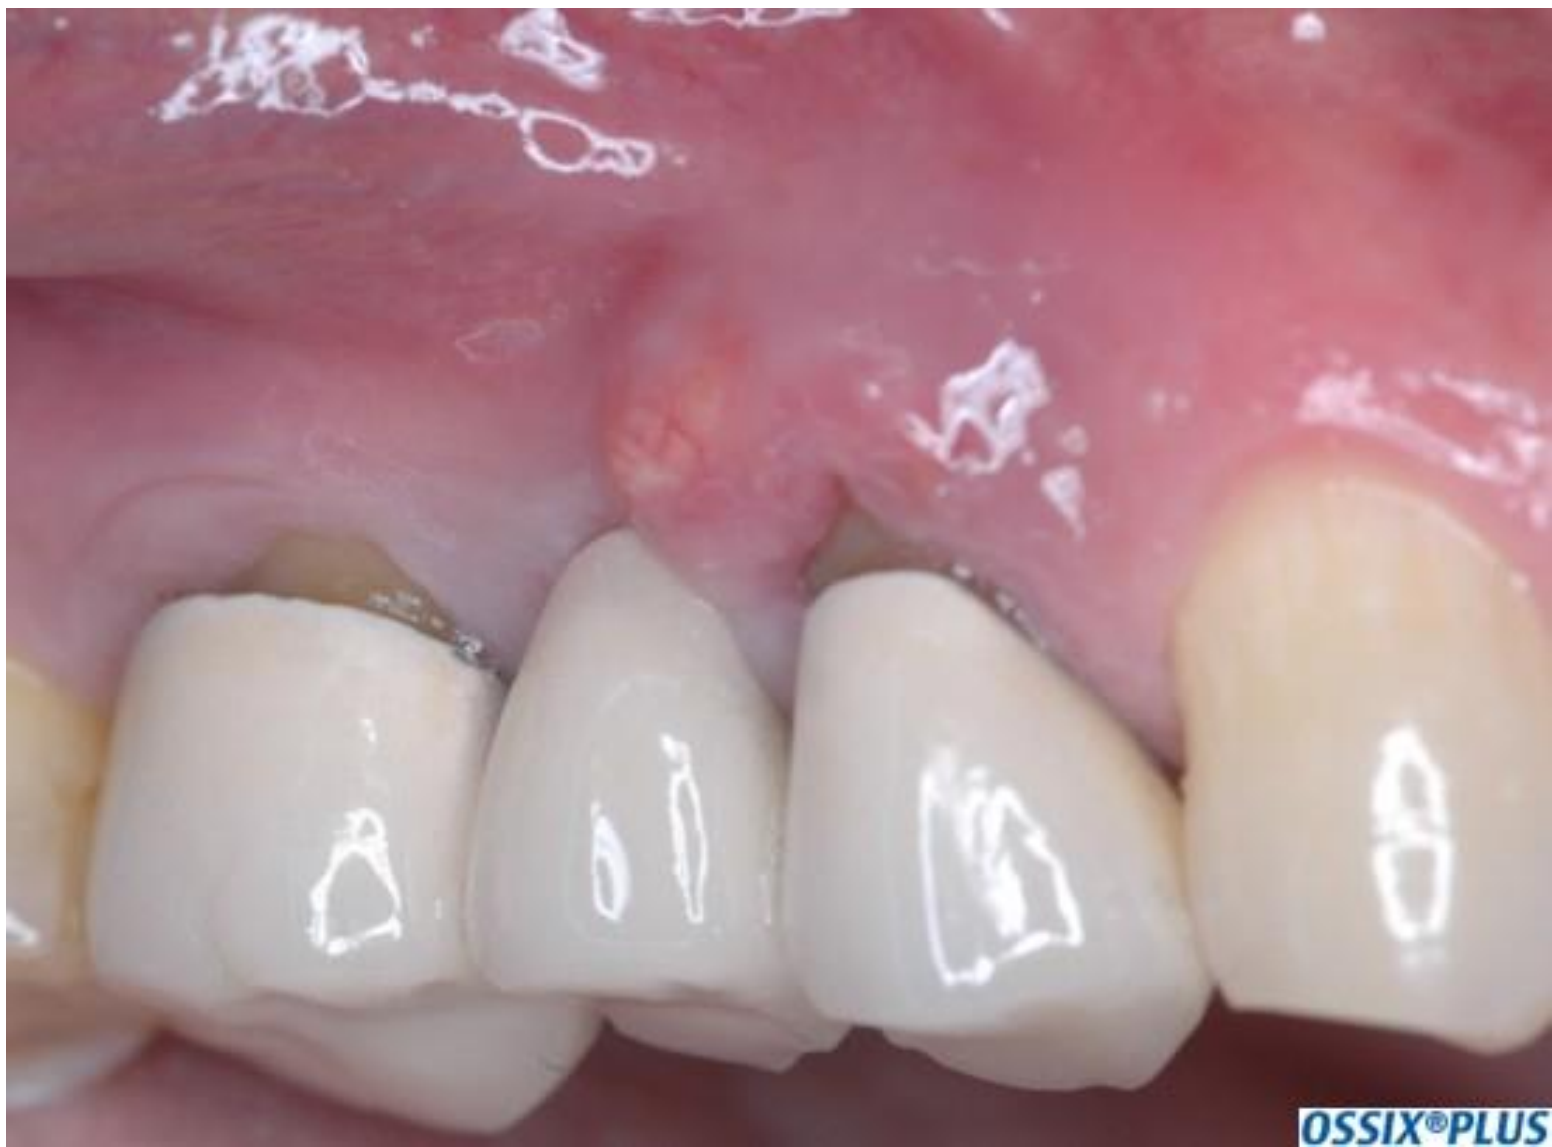
Pre-operative photograph showing acute abscess on the buccal aspect of tooth #5.

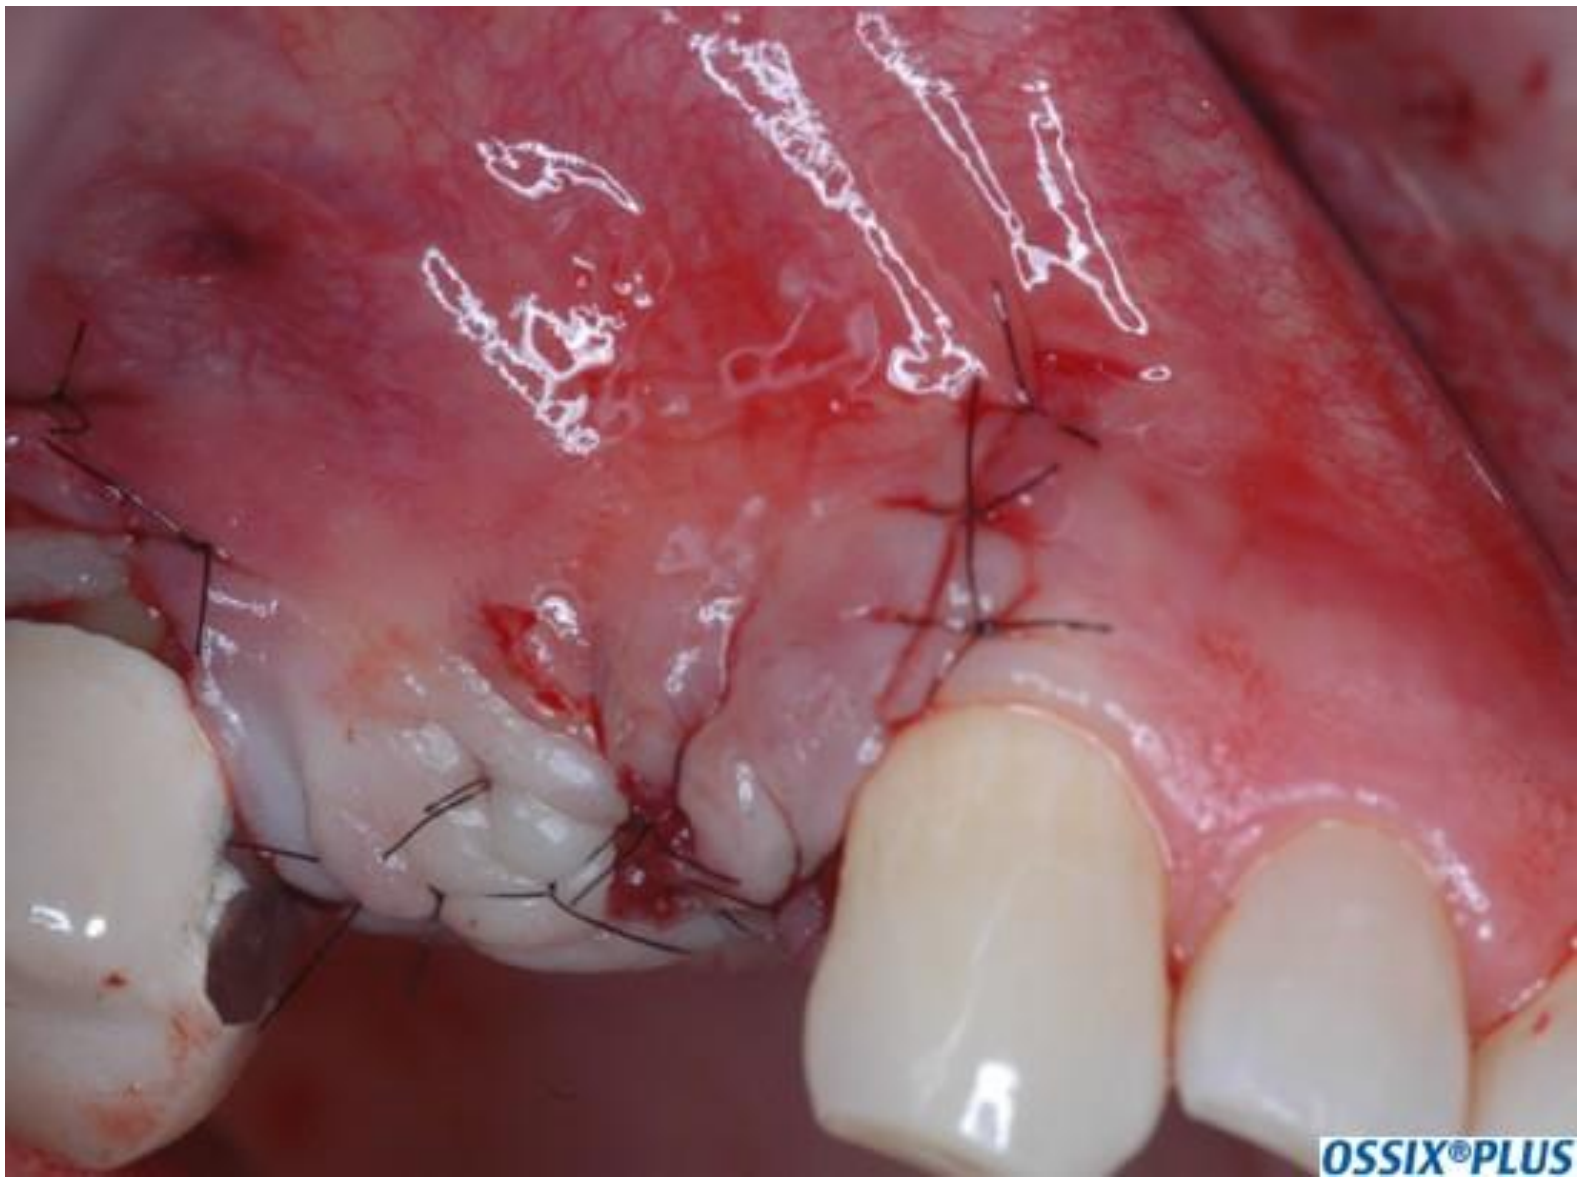
Soft tissue is sutured to accomplish tension free closure.

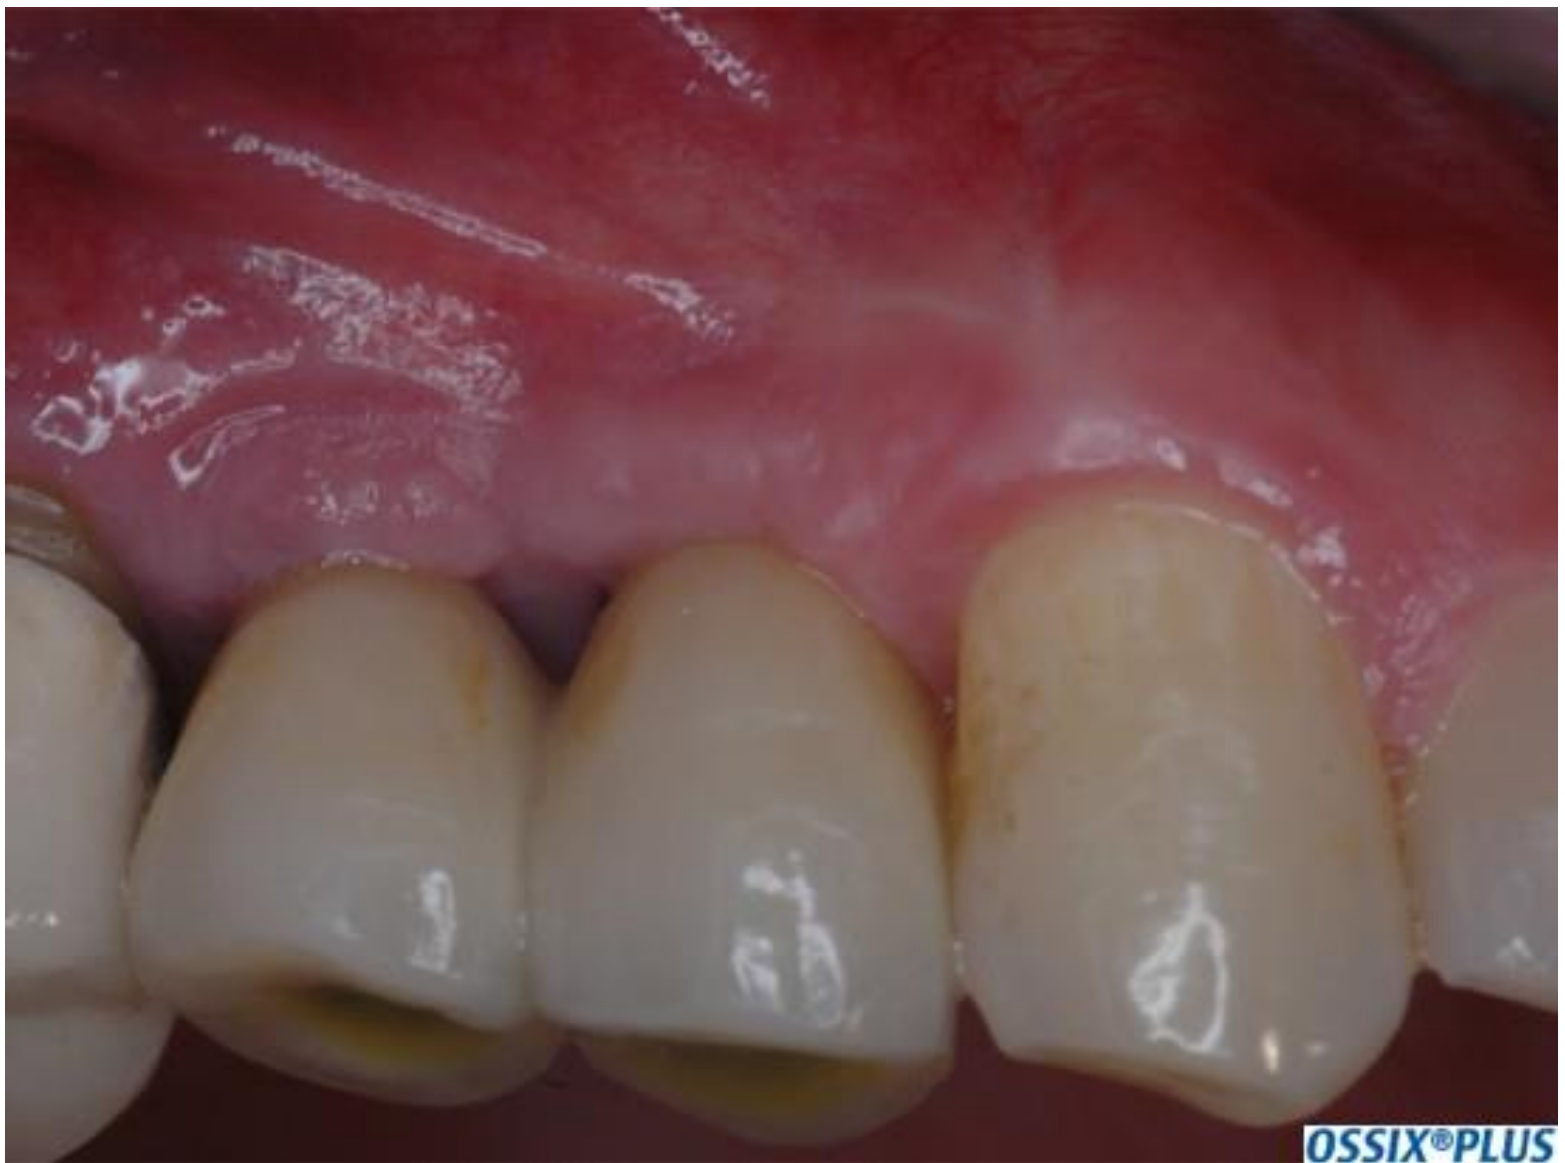
Final restoration after 3 years.
