OSSIX® PLUS Case Presentation #3

A 46 years old male with a missing tooth #12 and severe external root resorption of tooth #11.

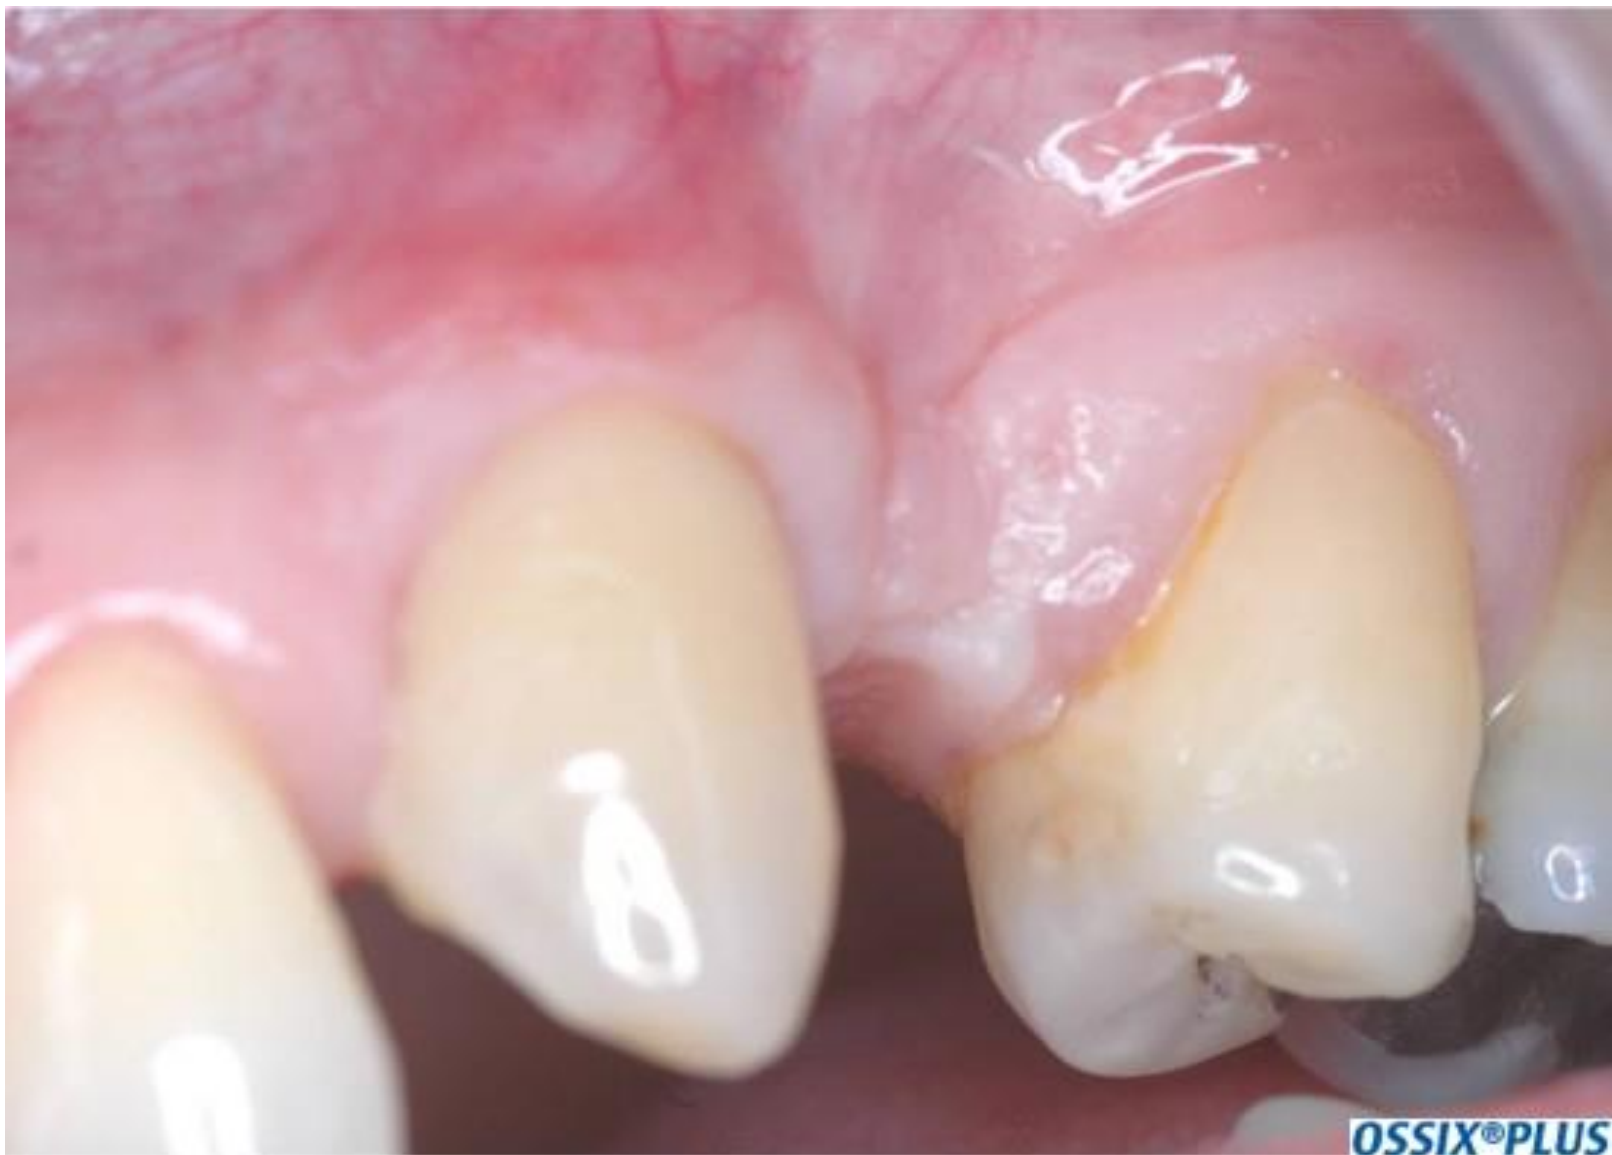
Clinical and radiographic photos of tooth #11 with severe root resorption and a missing tooth #12.

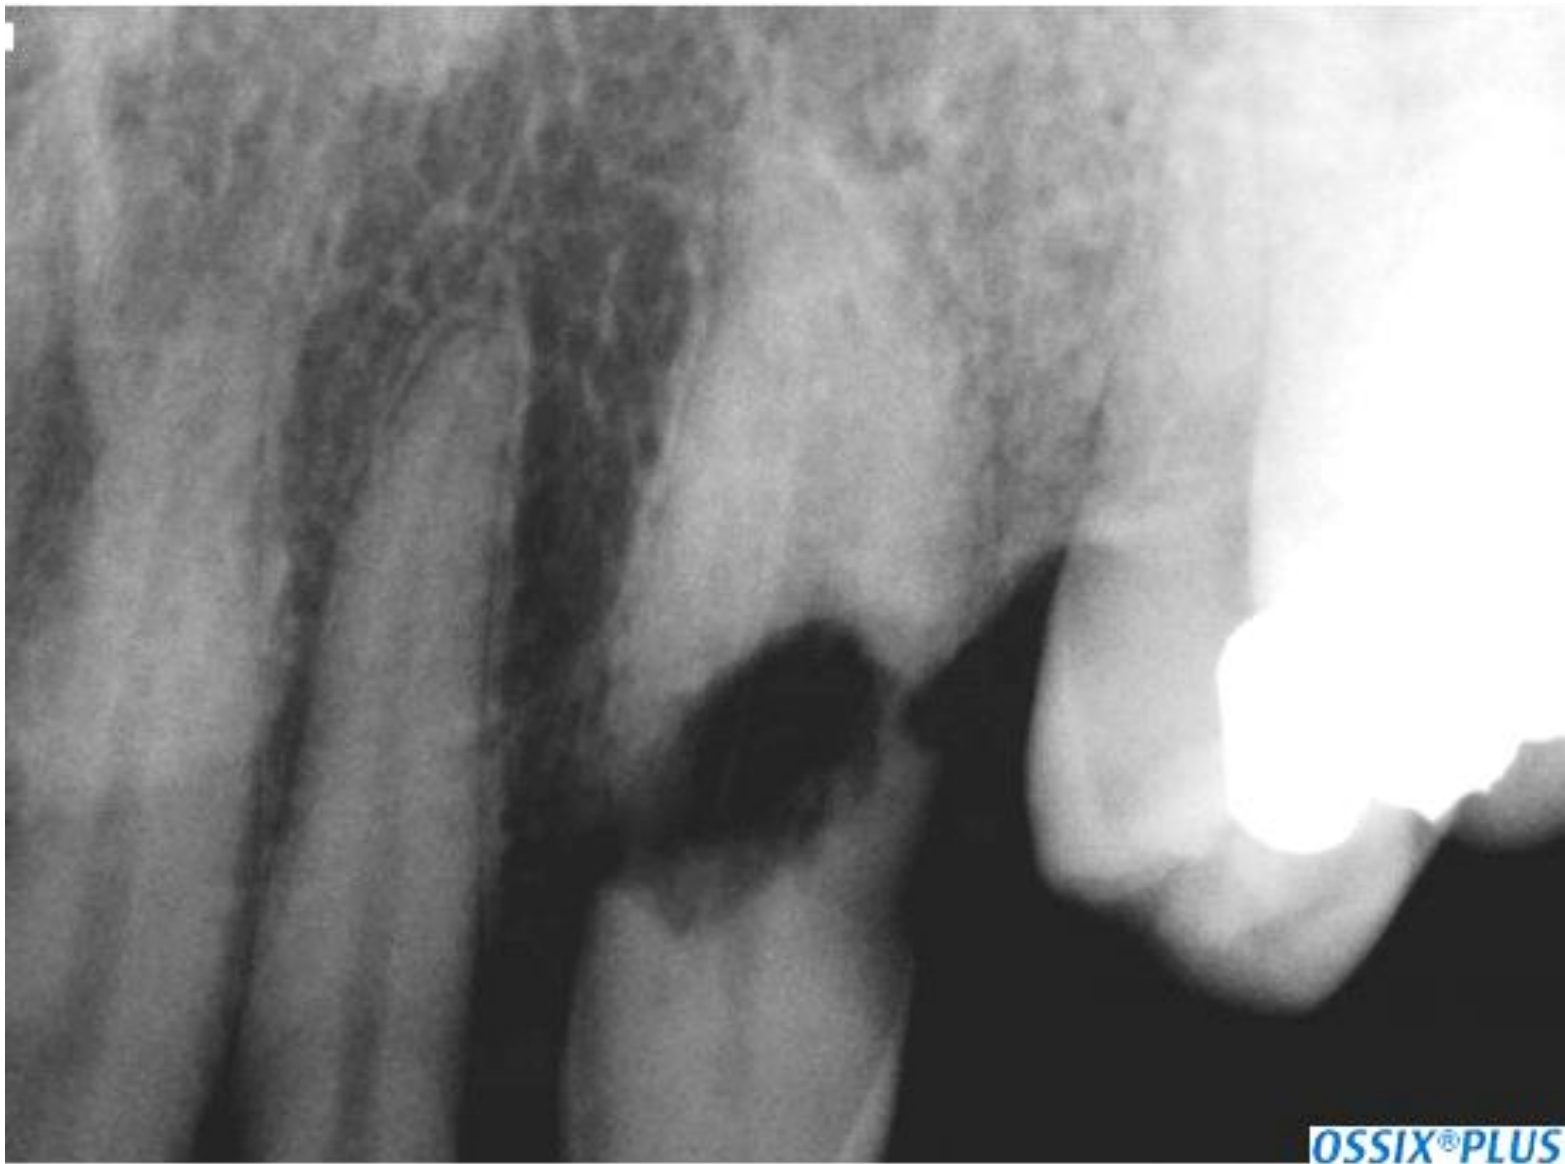
Clinical and radiographic photos of tooth #11 with severe root resorption and a missing tooth #12

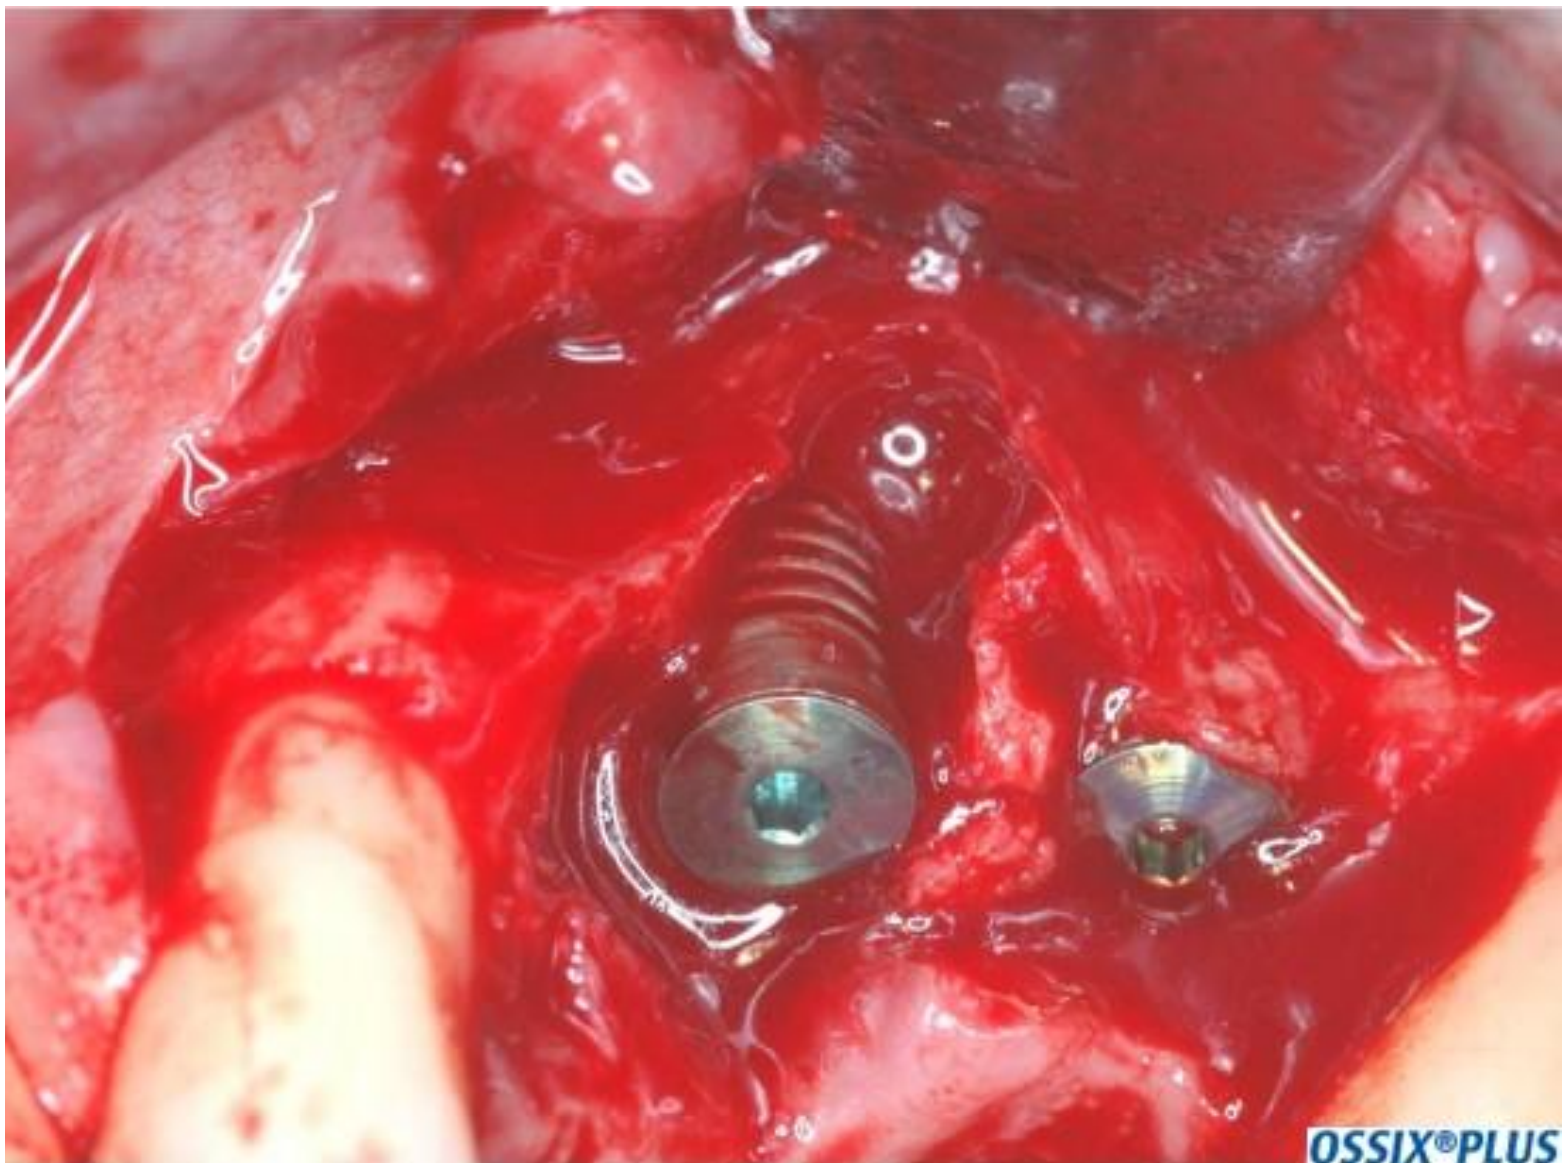
Following extraction of tooth #11 and placement of two implants, extensive bone loss and thin buccal bone.

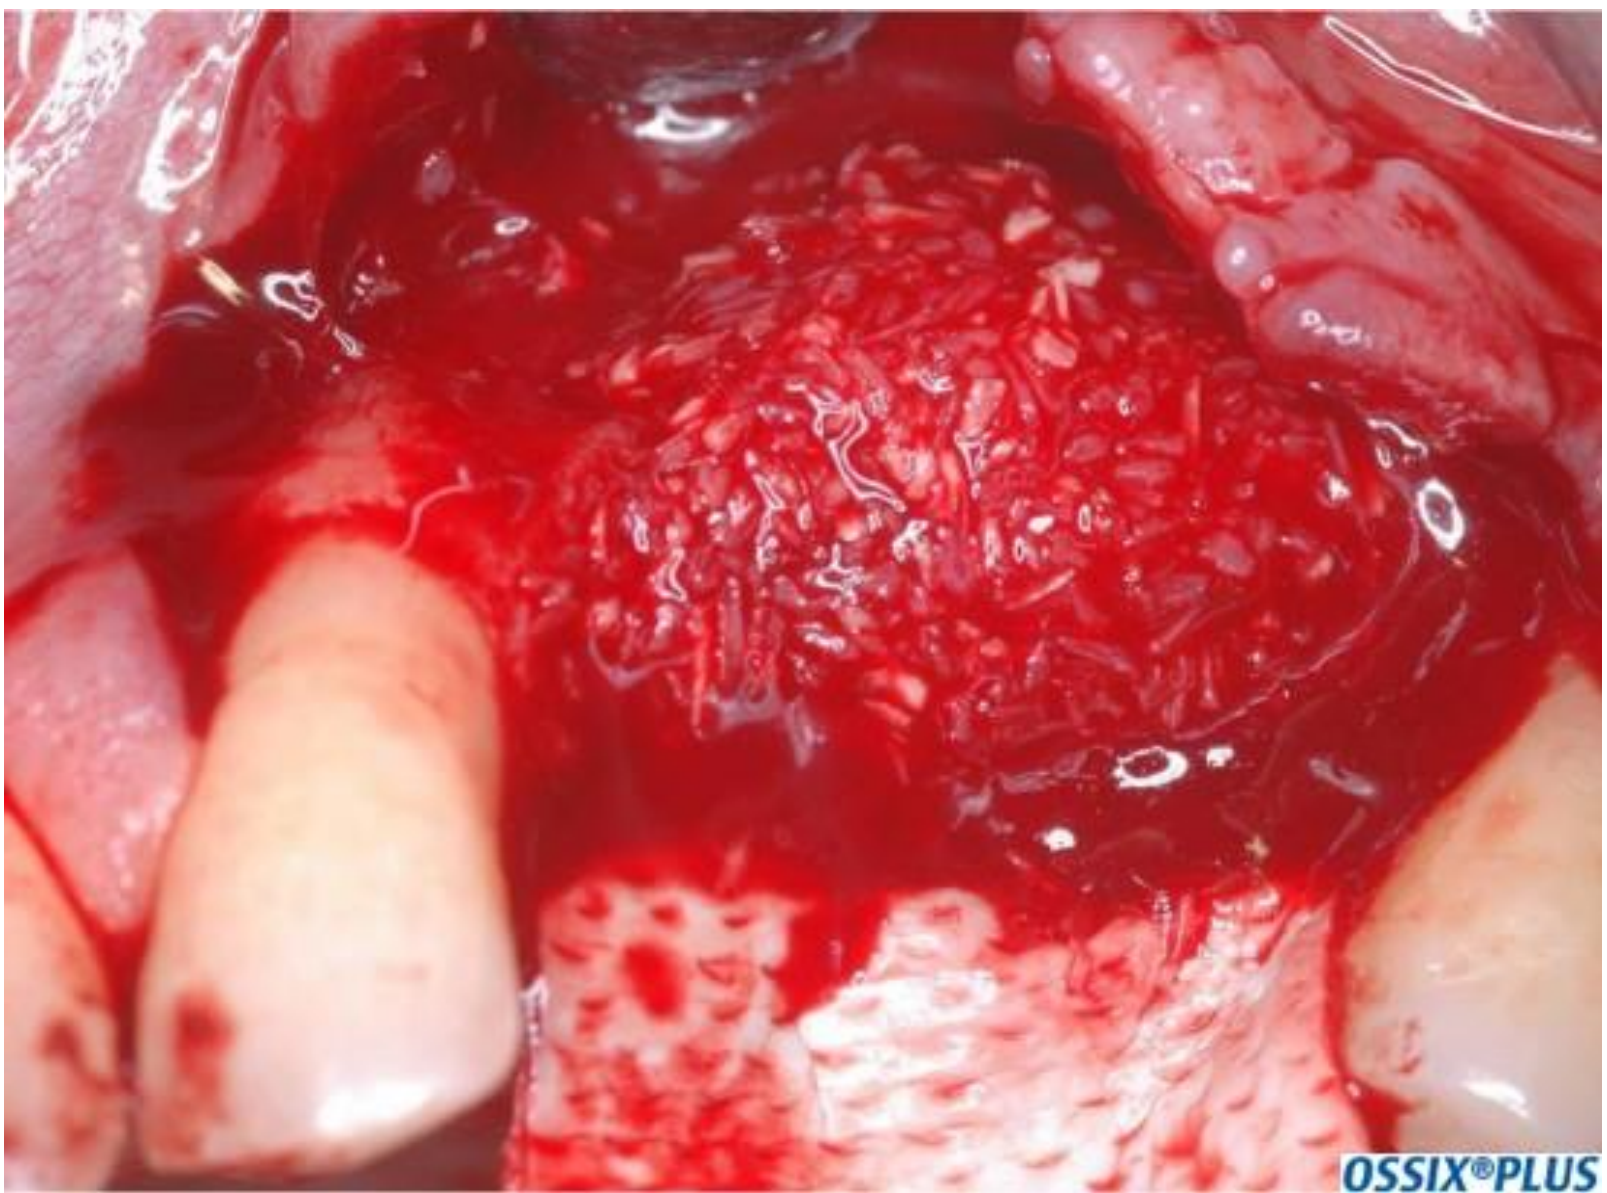
The ridge is augmented with FDBA and covered with OSSIX® PLUS fixated with bone tacks

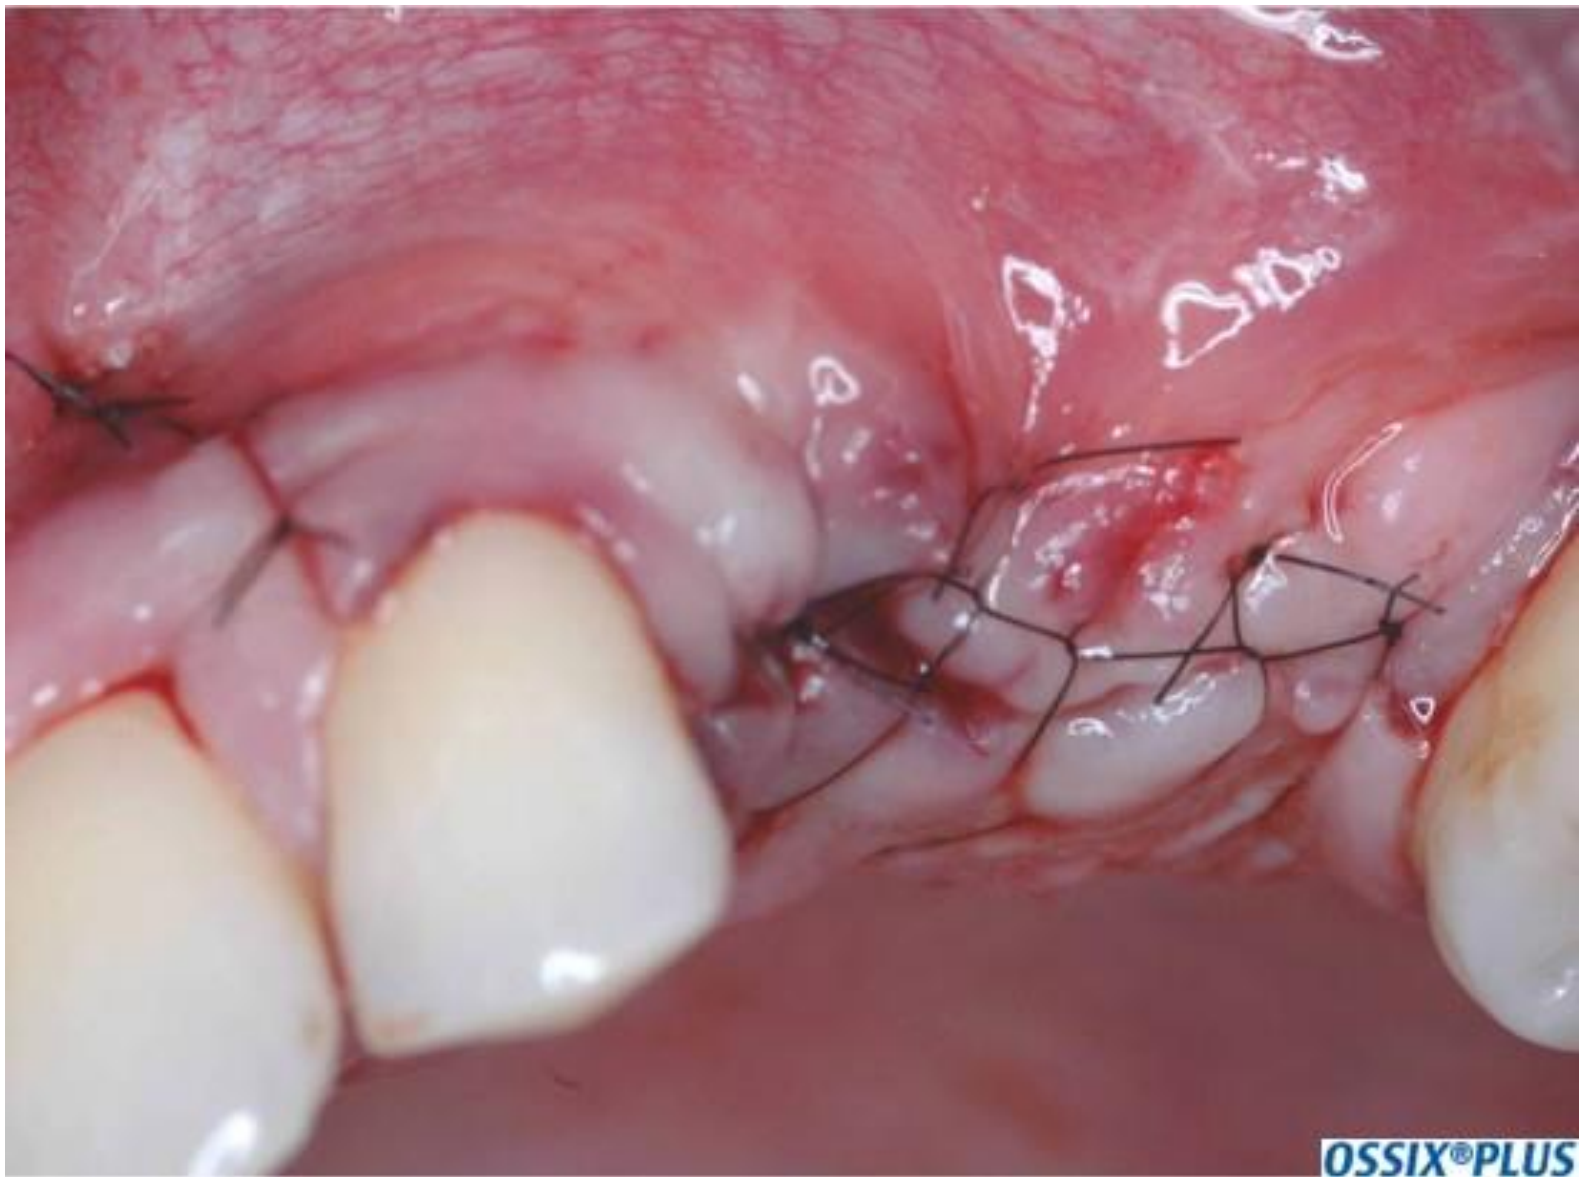
Primary soft tissue closure with 6-0 nylon sutures resulted in complete submerged healing.

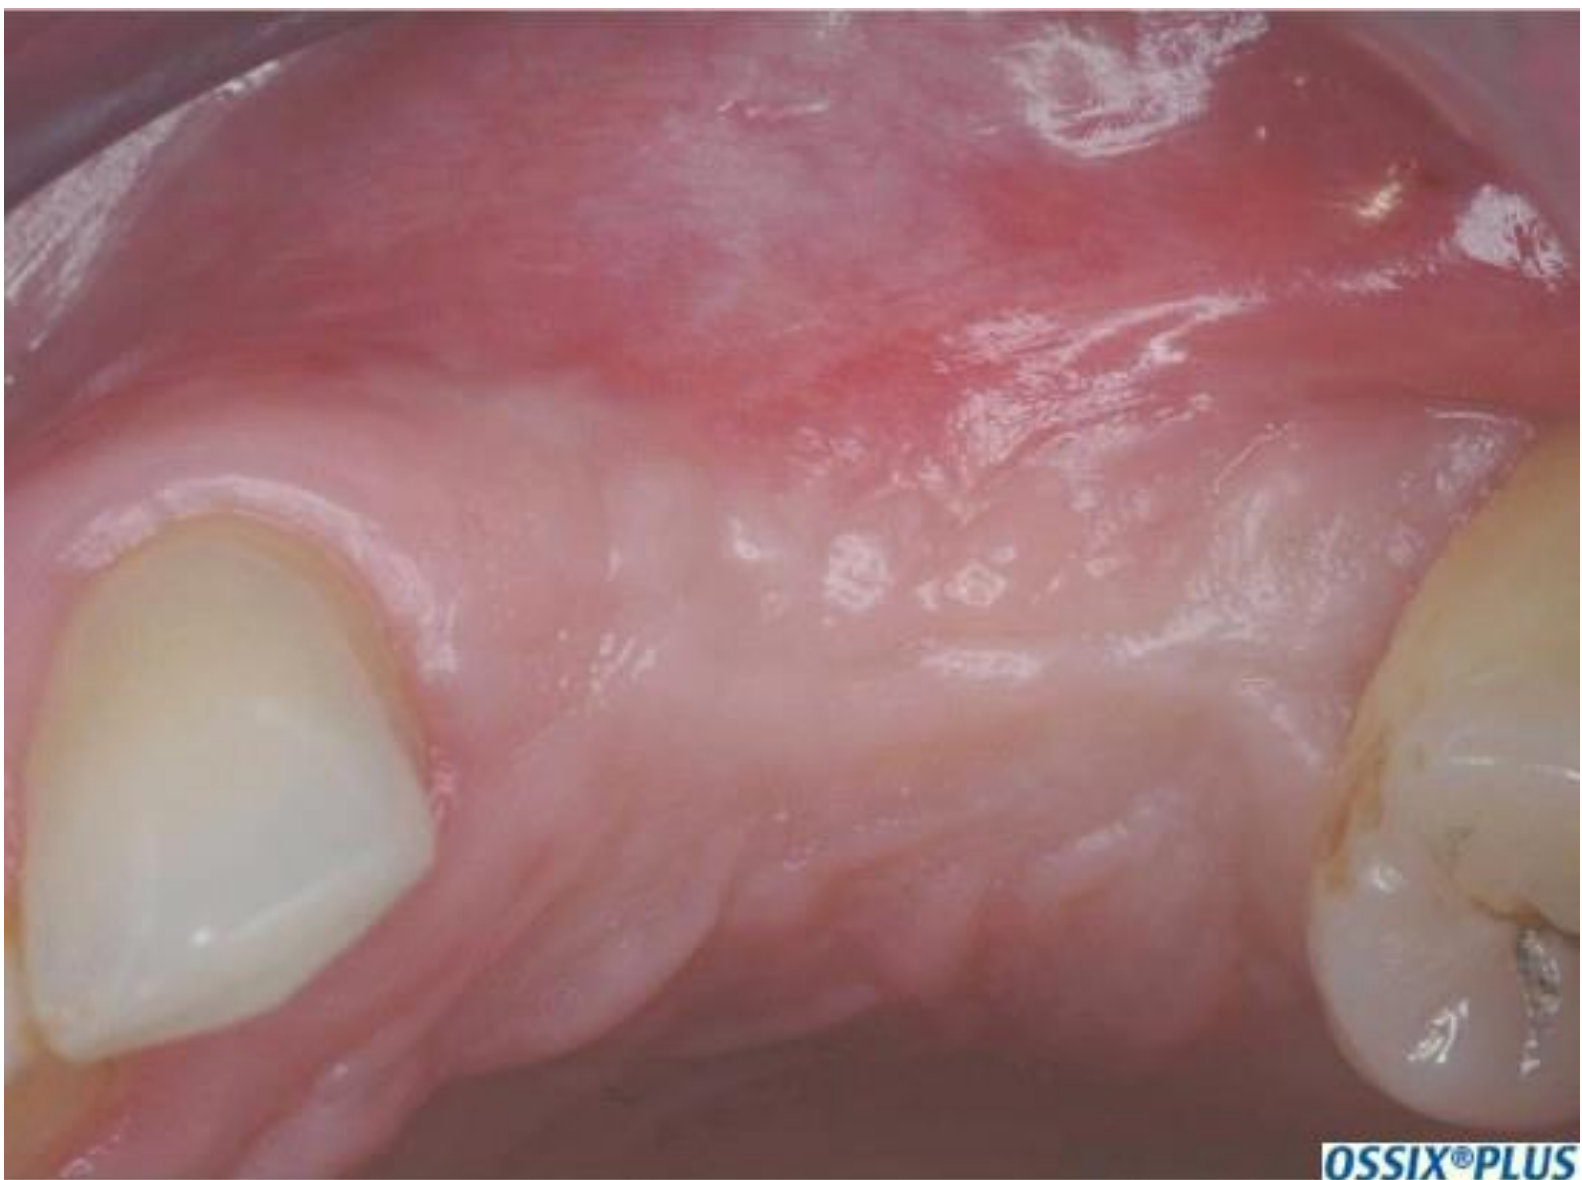
Primary soft tissue closure with 6-0 nylon sutures resulted in complete submerged healing.

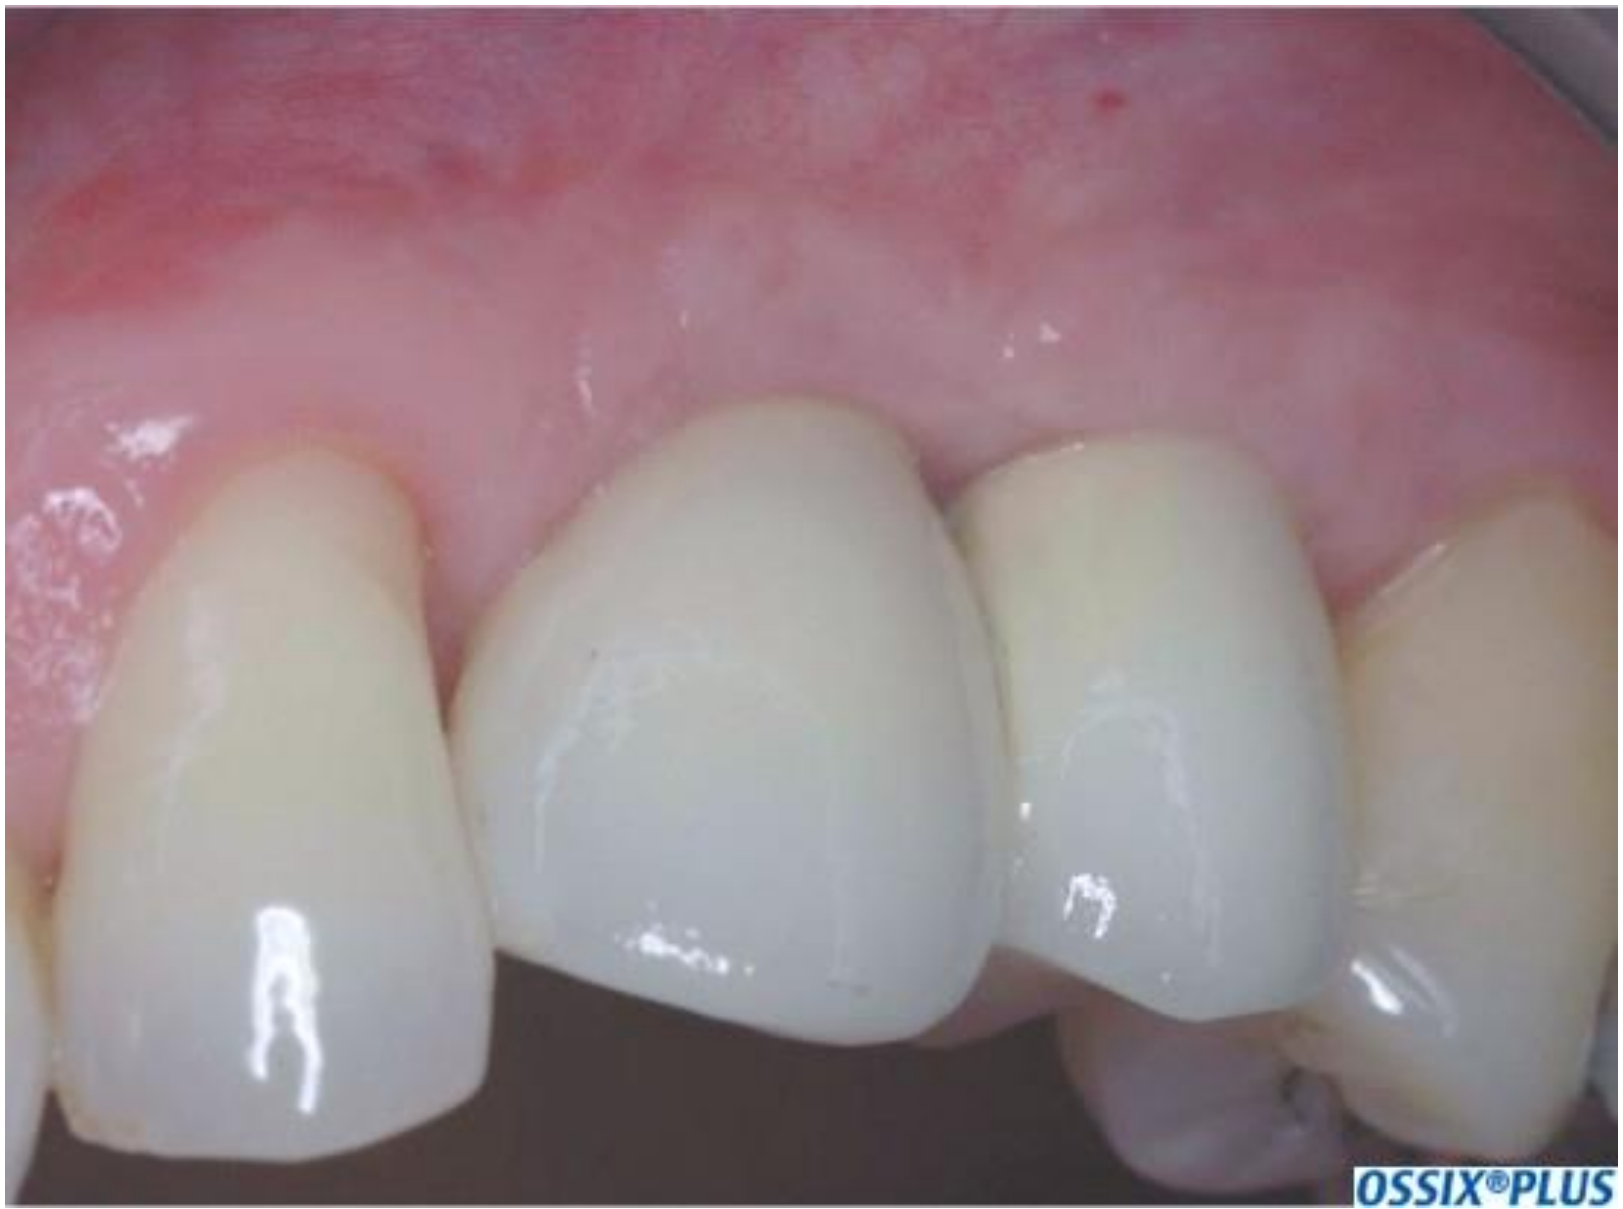
Clinical and radiographic photos of final prosthesis.
